# Manhole Inspection Summary

Manhole # S07KK1002MH

Insp Date: **5/18/07 10:46 AM**

**Location** Address: **4914 REISTERSTOWN RD**

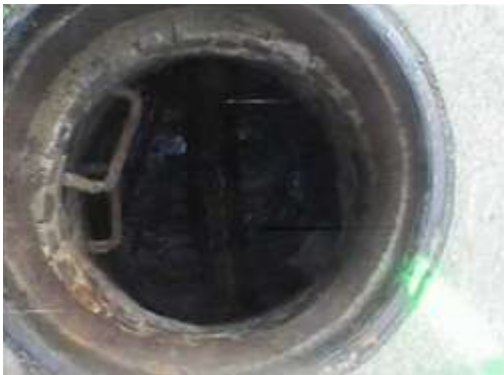
Defect 2

Offset: **3** (in.)

FRAME OFFSET

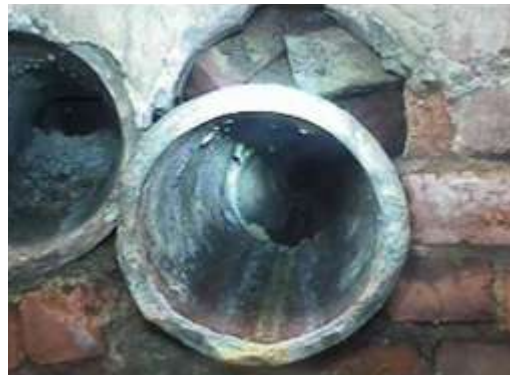
Defect 1

Condition: ☐ Sound ☒ **Cracked** ☐ Root Intrusion ☐ Loose Brick ☐ Deteriorated

BARREL CRACKED AROUND PIPE

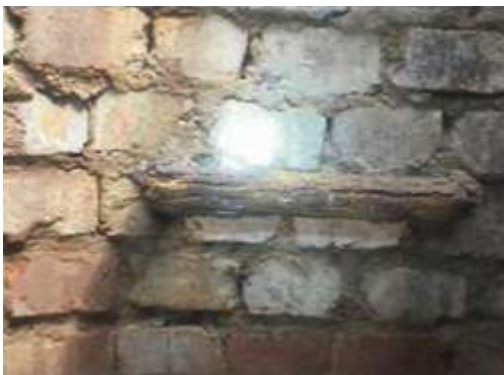
Count: **3** Missing: **0** ☒ **Corroded**

CORRODED RUNG

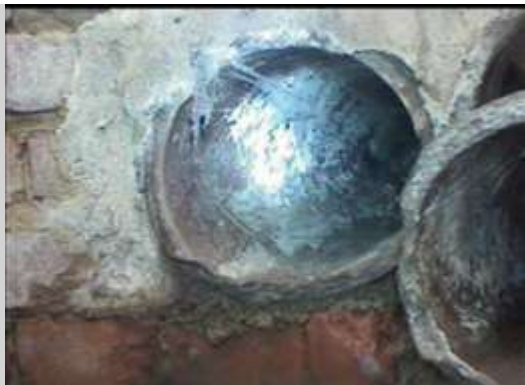
3 O'Clock Inflow

6 in. Circular Gravity Sewer  
Pipe In @ 3 O'Clock

Infiltration: **None** Pipe Seal Cond: **Cracked**

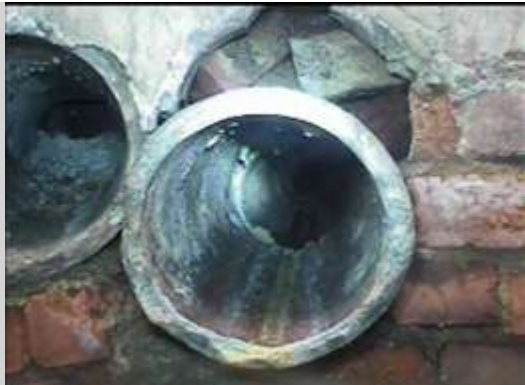
4 O'Clock Inflow

6 in. Circular Gravity Sewer  
Pipe In @ 4 O'Clock

Pipe Seal Cond: **Broken**
